Manhole Inspection Summary

Manhole # S55I__039MH

Insp Date: **5/29/08 2:40 PM**

Location Address: **3700 eastern ave**

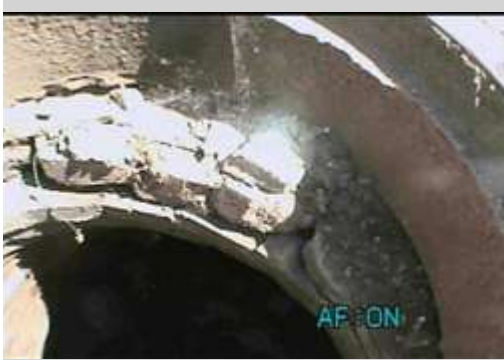
Defect 1

Offset: **6** (in.)

Condition: ☐ Sound ☒ **Cracked** ☐ Leaks

Condition: ☐ Sound ☐ Cracked ☐ Root Intrusion ☒ **Loose Brick** ☐ Deteriorated

offset, frame cracked, loose bricks in corbel

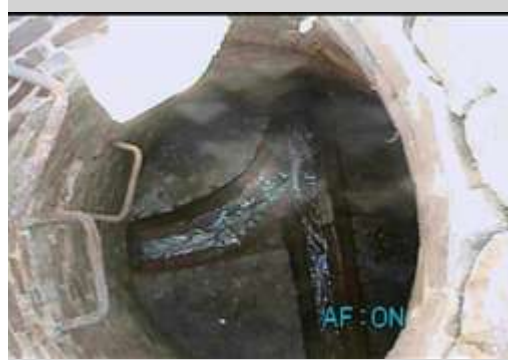
Defect 2

Count: **3** Missing: **0** ☒ **Corroded**

steps

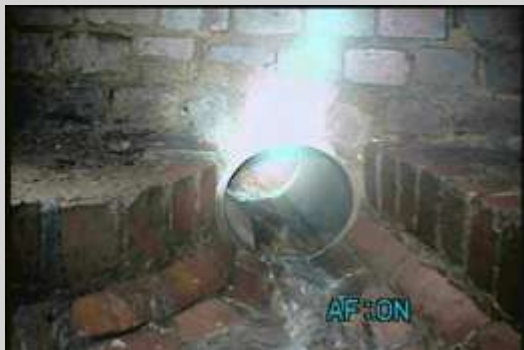
12 O'Clock Outflow

8 in. Circular Gravity Sewer
Pipe Out @ 12 O'Clock

Deposits: ☒ None ☐ Mud ☐ Sludge ☐ Debris ☐ Grease

Infiltration: **None** Pipe Seal Cond: **Unknown**

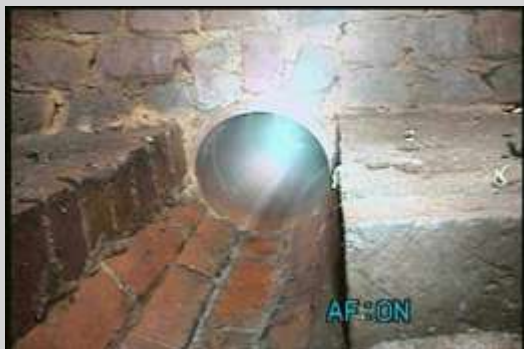
6 O'Clock Inflow

8 in. Circular Gravity Sewer
Pipe In @ 6 O'Clock

Deposits: ☒ None ☐ Mud ☐ Sludge ☐ Debris ☐ Grease

Infiltration: **None** Pipe Seal Cond: **Unknown**

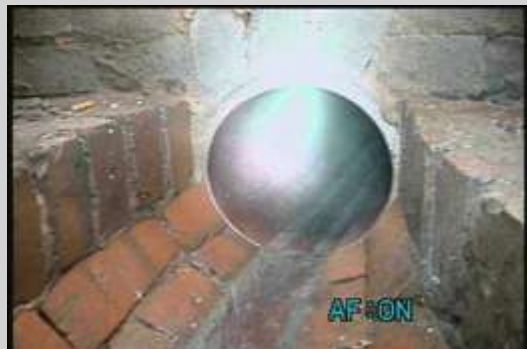
9 O'Clock Inflow

8 in. Circular Gravity Sewer
Pipe In @ 9 O'Clock

Deposits: ☒ None ☐ Mud ☐ Sludge ☐ Debris ☐ Grease

Infiltration: **None** Pipe Seal Cond: **Unknown**
